A Review of Implant Screw Fractures: Their Causes and Methods of Retrieval

by Beatrice Leung, DDS, MPH, Cert Pros, FRCD(C), FACP

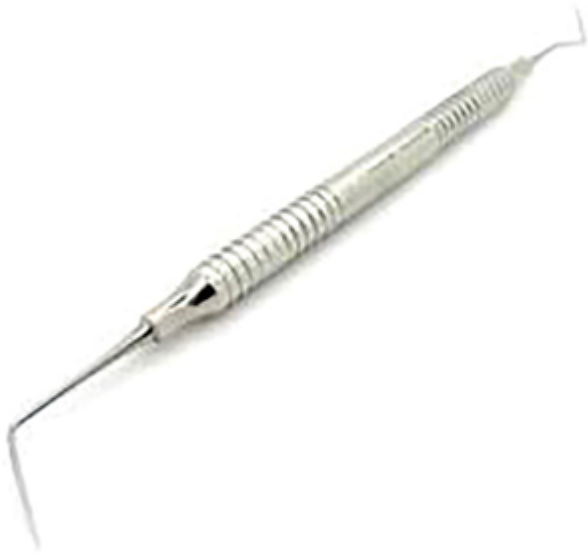
Figure 3

Explorer.

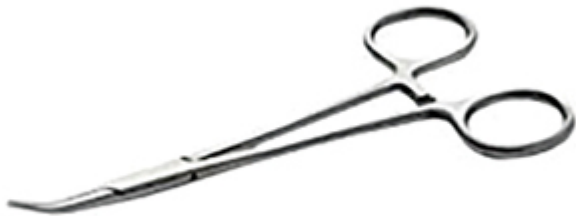
Figure 4

Curved hemostat.

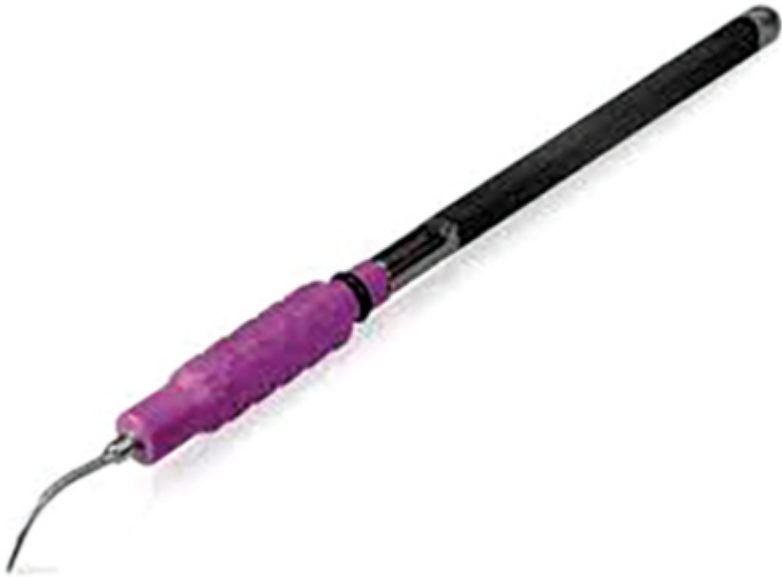
Figure 5

Ultrasonic scaler.

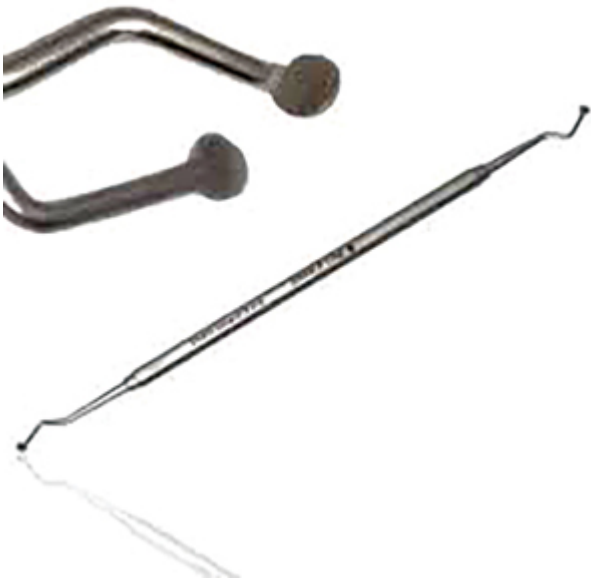
Figure 6

Spoon excavator.

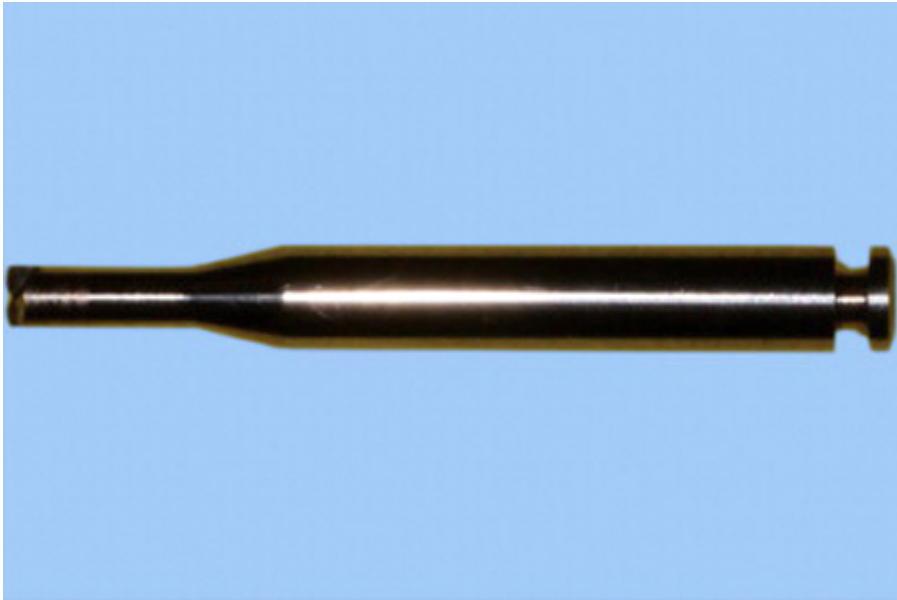
Figure 8

Picture of Fork Shaped End Instrument.

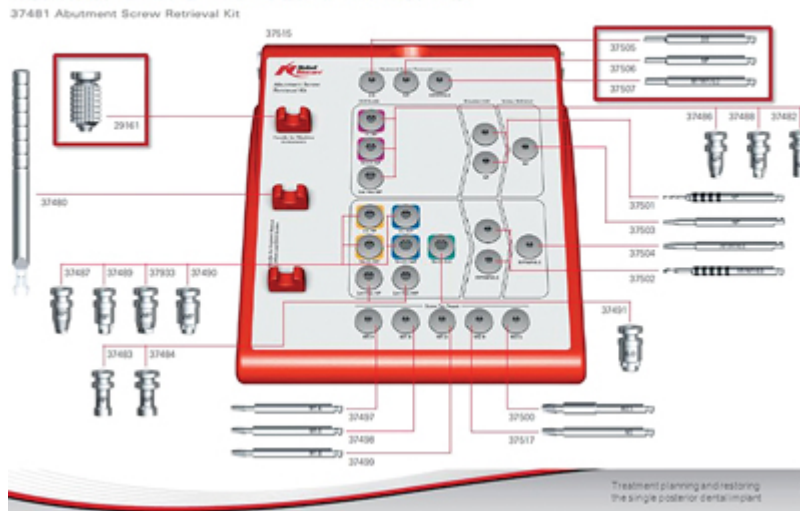
Figure 9

Nobelbiocare retrieval kit.

If the more conservative approach has proven not to work, then there are some commercially available retrieval tools and systems for purchase. Many major implant companies will carry their own if requested. Some dental implant suppliers have also created their own implant and screw rescue or retrieval kits for purchase. Many of these kits can be quite expensive. But many of them will carry similar items for the retrieval attempts. Most of these commercially available systems will include a set of drills of different dimensions, shapes and lengths. The goal is to engage the broken fragment and then applying reverse torque to back up the fragment. The kit will also include a set of drill guides or drill "sleeves". The goal is to align or angulate the drill in proper axial direction to the implant to minimize damage to the internal threads of the implants. Lastly, the kit will usually include a set of re-tapping tools and the goal is to re-thread the internal structure of the implant should there be any damage during the retrieval process. Yilmaz and Iman have both discussed a fork shaped end instrument from Astratech specially designed to engage the screw fragment. Once engaged the instrument can be placed in a slow speed hand piece and apply a reverse torque to back up the loose fragment. ¹² Nergiz et al. described using IMZ TwinPlus Repair Set K 3.3 from Dentsply Friadent. ¹³ Luterbacher et al described the service set available for the ITI system.

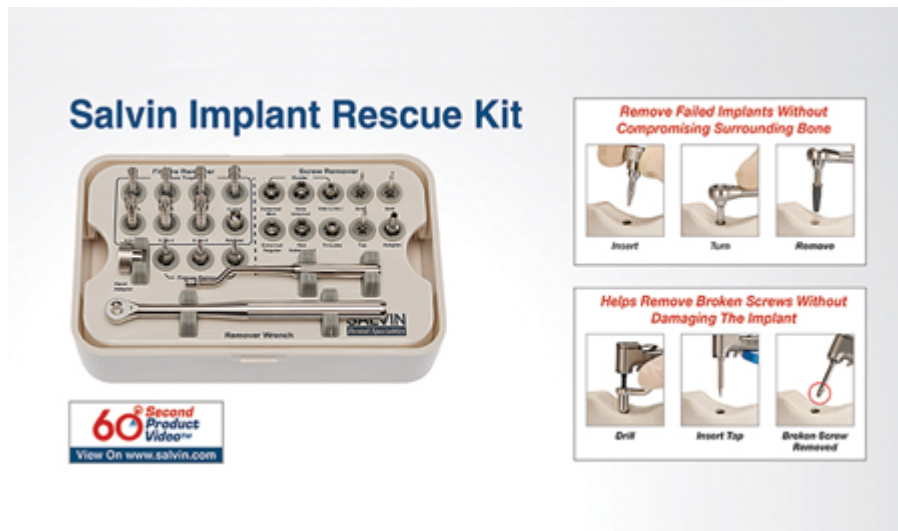
Figure 10

Salvin Implant Rescue kit.

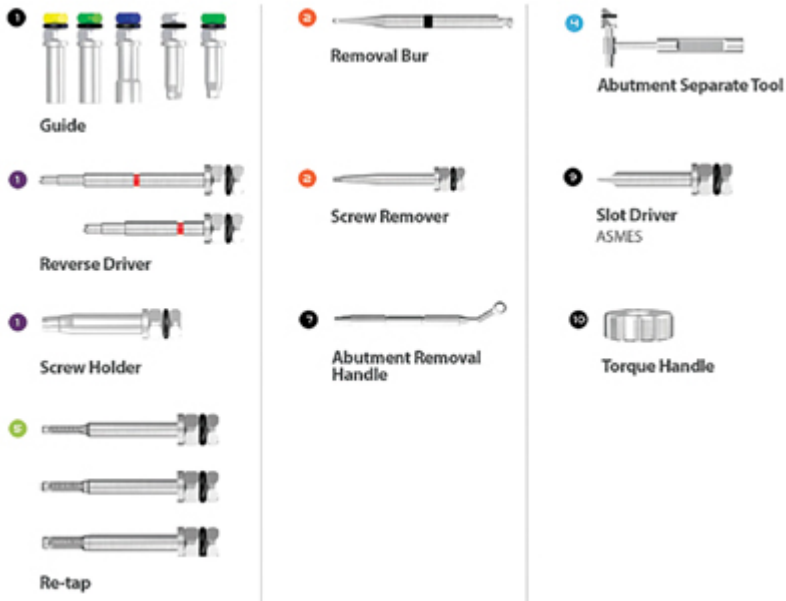
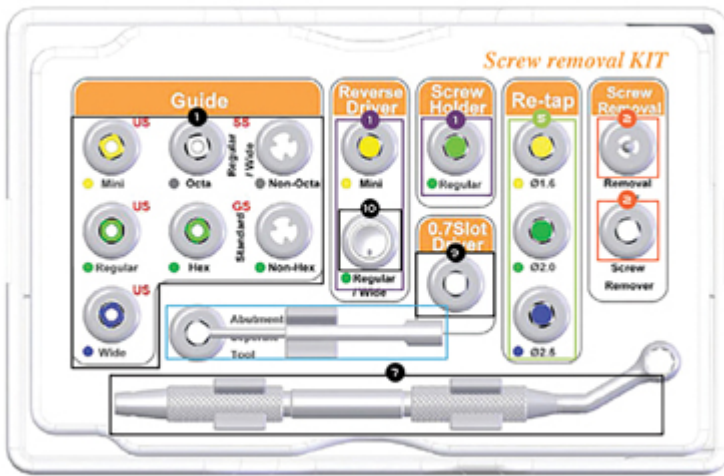
Figure 11

Screw Removal Kit OSSVK+detail.

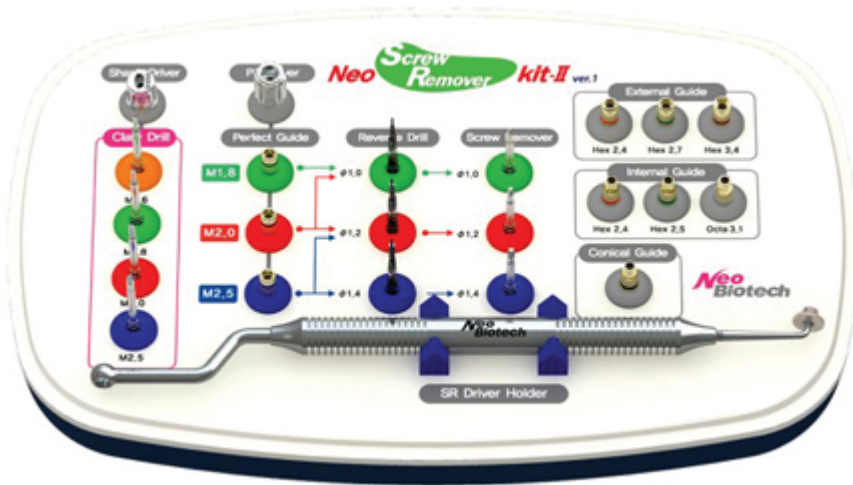
Figure 12

Neobiotech Screw Removal kit.

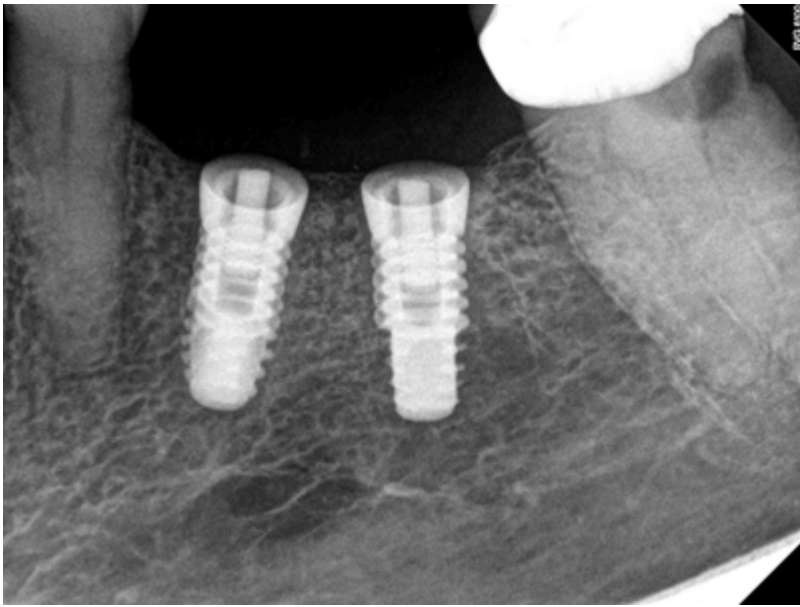
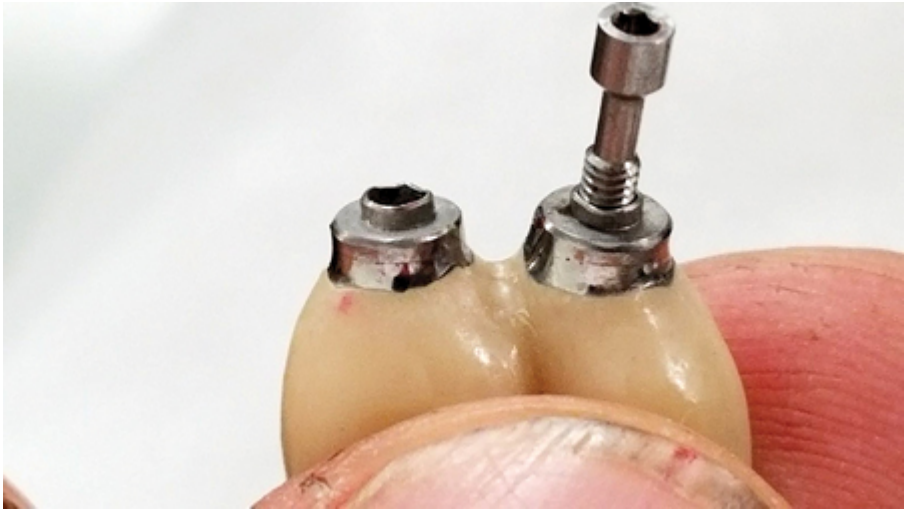
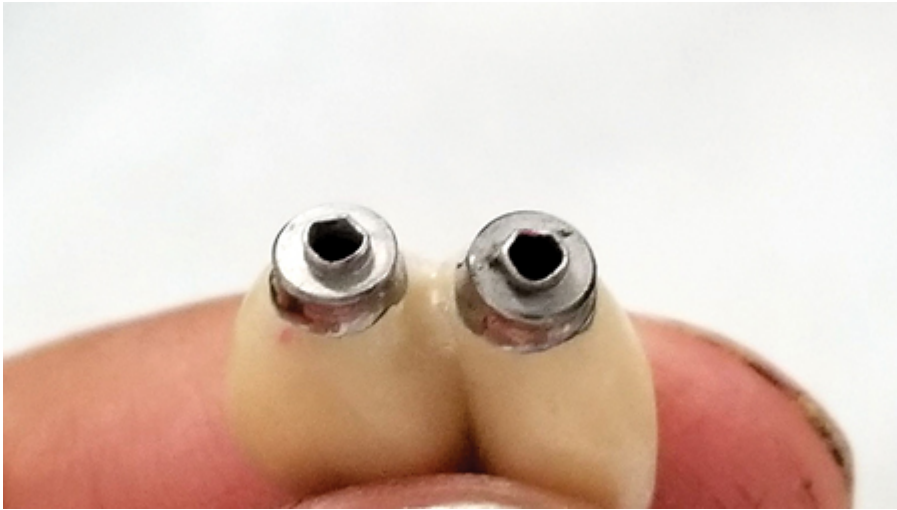
Case 1:

This is a patient who presented to the clinic with splinted implant crowns that fractured off the implants. Examination and radiographs revealed the splinted crowns completely separated from the implants. Screw fragments were visible above the implants and were noted to be loose. A hemostat was used to secure the fragments separately and slowly rotated in the counter-clockwise direction to retrieve both fragments. The other fragments remained inside the crowns and have been removed through the access holes. It was noted however that with the new screws that were ordered, they did not fit through the screw channels of the implant crowns. It was discovered that the channels for the screws might have been distorted during the process of screw fracture. The case was sent to the lab for further evaluation and the screw channels had to be adjusted until the screws can fit into them again. The splinted implant crowns were later re-inserted and torqued to 32Ncm.

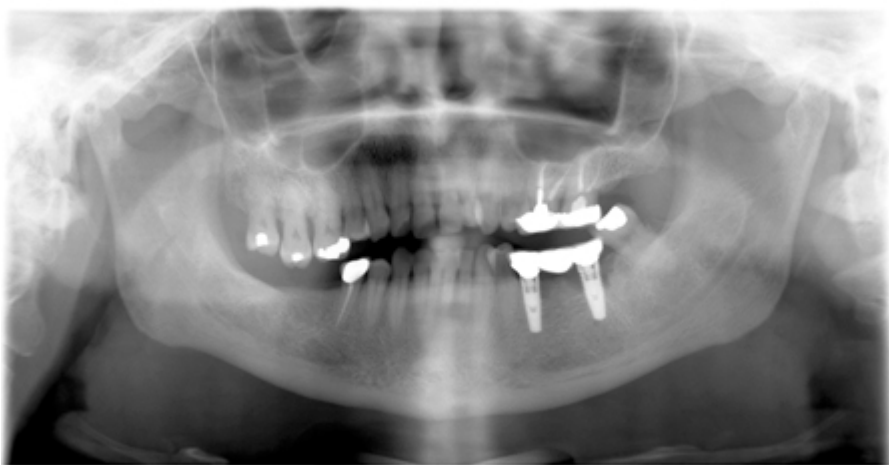
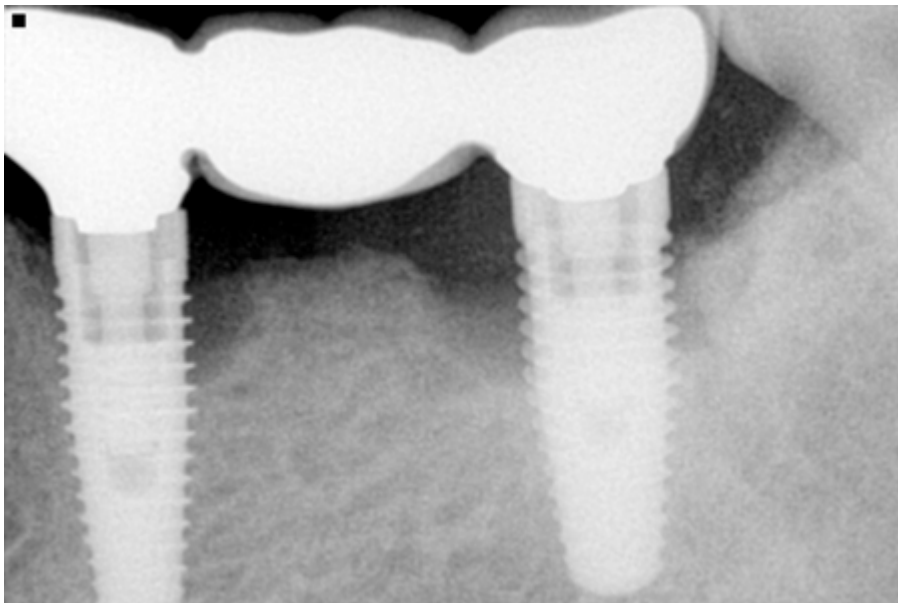
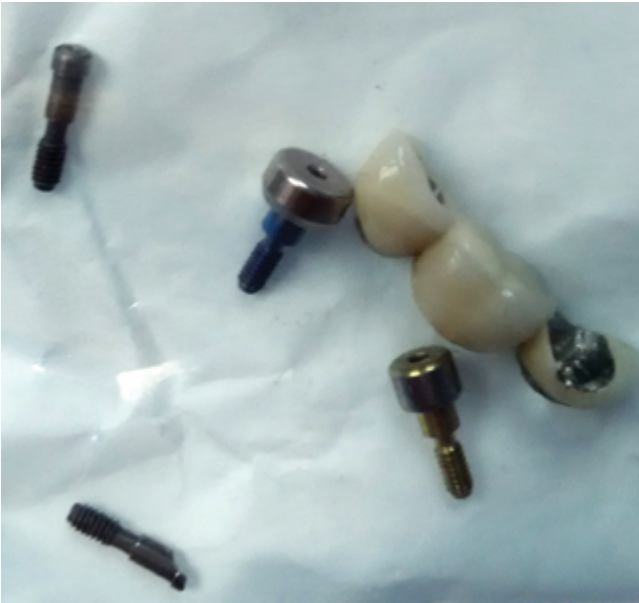
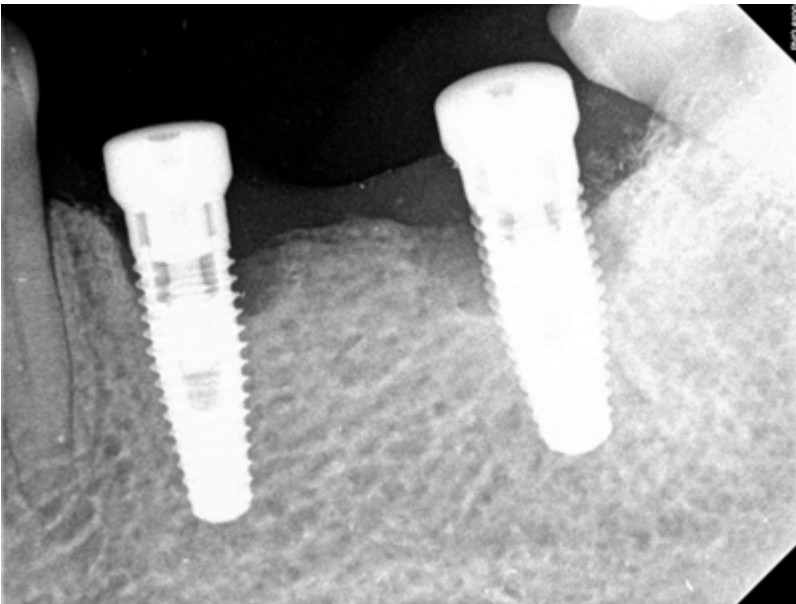
Case 2:

This is a patient referred to remove an implant bridge 36-x-34. The prosthetic screw at implant site 36 was stripped and the patient also had limited mouth opening. Upon evaluation, an initial attempt was made to remove the stripped screw using conservative methods. However, with the limited mouth opening, that initial attempt was proven to be unsuccessful. It was later decided to enlarge the screw access opening on the occlusal surface to improve visibility. This is important especially for someone with limited mouth opening. The larger than normal access will allow the screwdriver or instruments to have greater freedom of maneuvering over the site for retrieval. In this case it was later noted there was binding between the walls of access opening and the screw. A ring of space was created surrounding the broken screw and slot like configuration created on the exposed screw. The bridge eventually became loose and it was removed to allow for better visibility. After the bridge was removed, the screw remained inside the body of the implant body. It was later removed with using a hemostat.

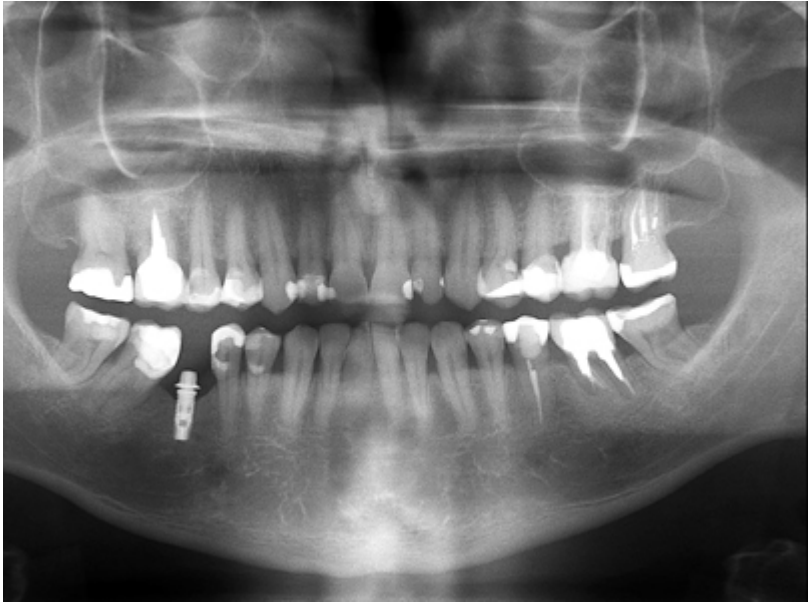
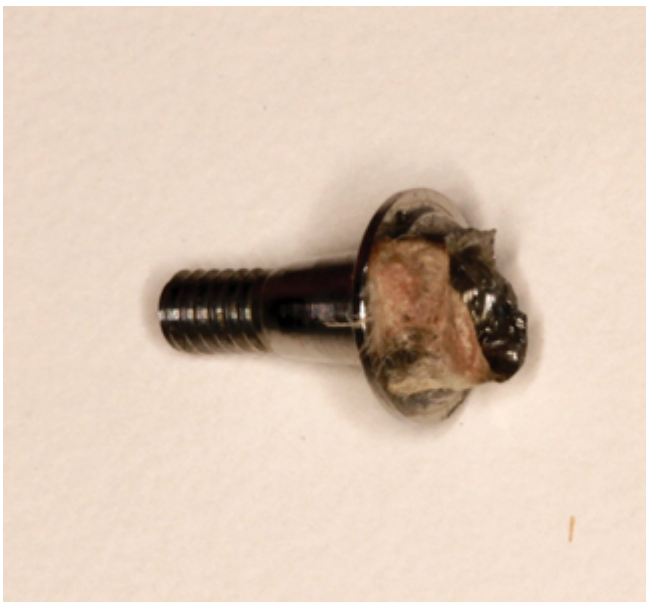
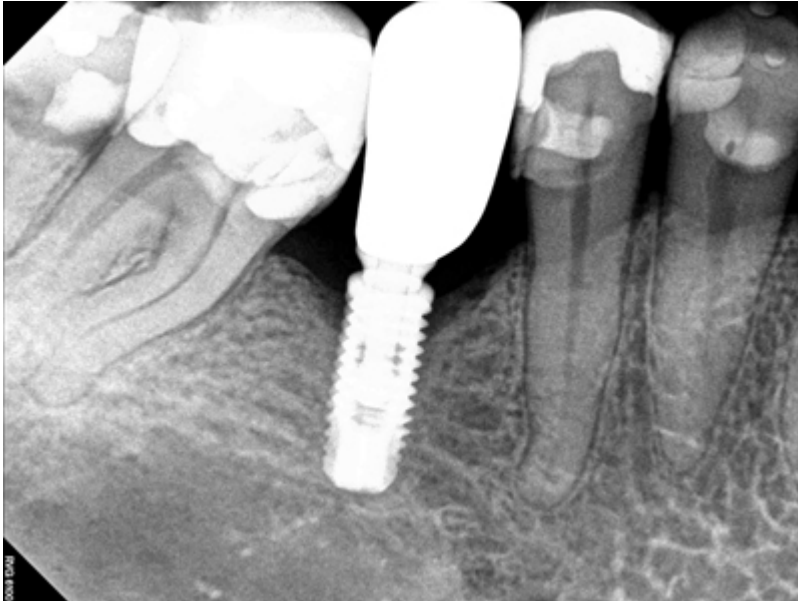
Case 3:

This is a patient referred for screw removal. According to the history, the restorative crown was torqued over the suggested value. The resulting screw snapped off at the level of the abutment. This is an implant that has a Morse taper along with the screw connection. During the examination phase, it was discovered that the abutment screw was flushed with the abutment. An attempt was made to create a slot configuration with the abutment screw. But it was proven to be ineffective due to the small available surface area. The decision was later made to forgo the abutment. The top

portion of the abutment was reduced and flattened intentionally to remove previously made scratches. A ring of space was created around the broken screw. A slot configuration was created and the entire abutment was removed using a slot driver by applying a counter clockwise direction. The implant was later restored with a screw retained implant crown.
